HOL-GAR MODEL SP-HF-15, 15-KW,
400-HERTZ ENGINE GENERATOR SET

Army Mobility Equipment Research and
Development Center
Fort Belvoir, Virginia

May 1969

Report 1951

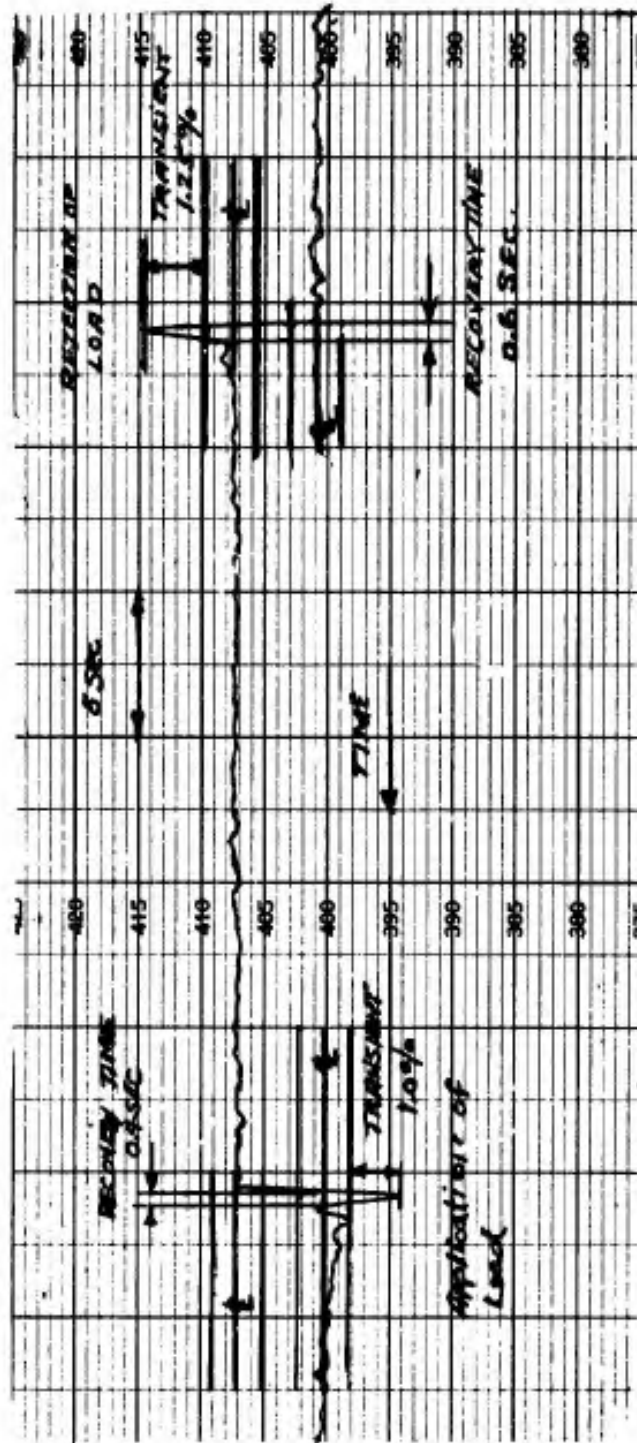
Fig. 4. Frequency stability and transient response at rated load, sea level, minus 25° F.

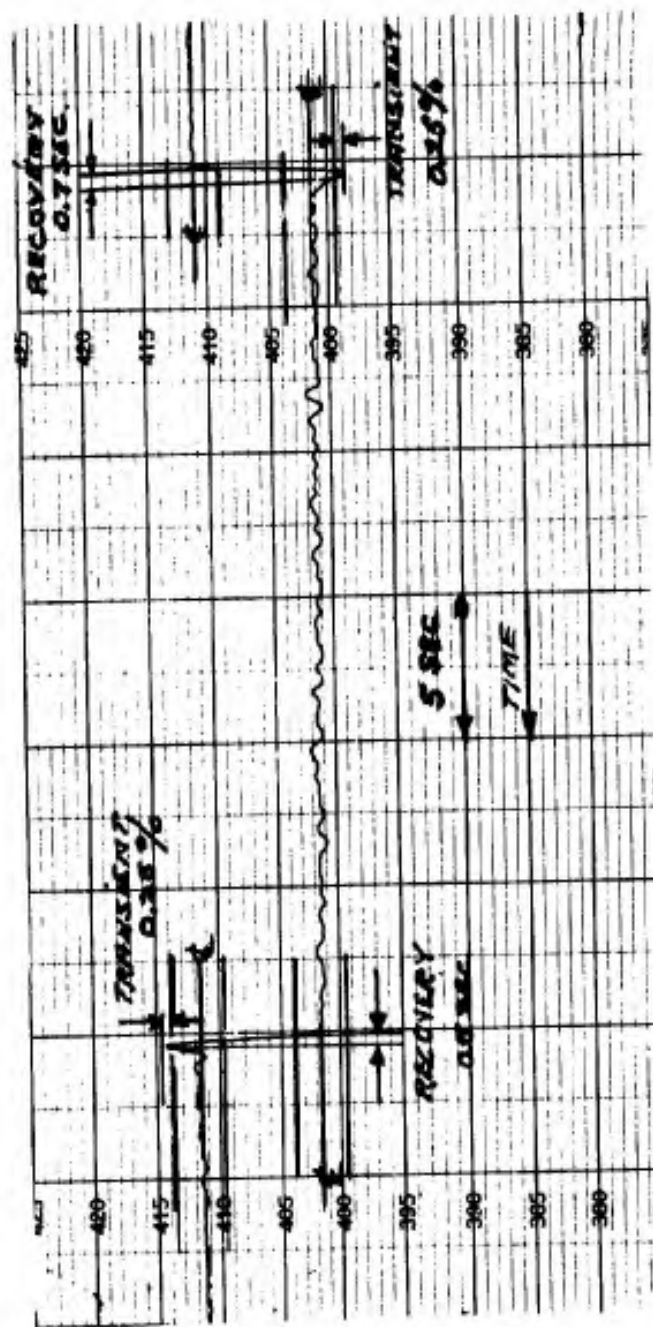
Fig. 5. Frequency stability and transient response at rated load, 8,000 Ft, 95° F.

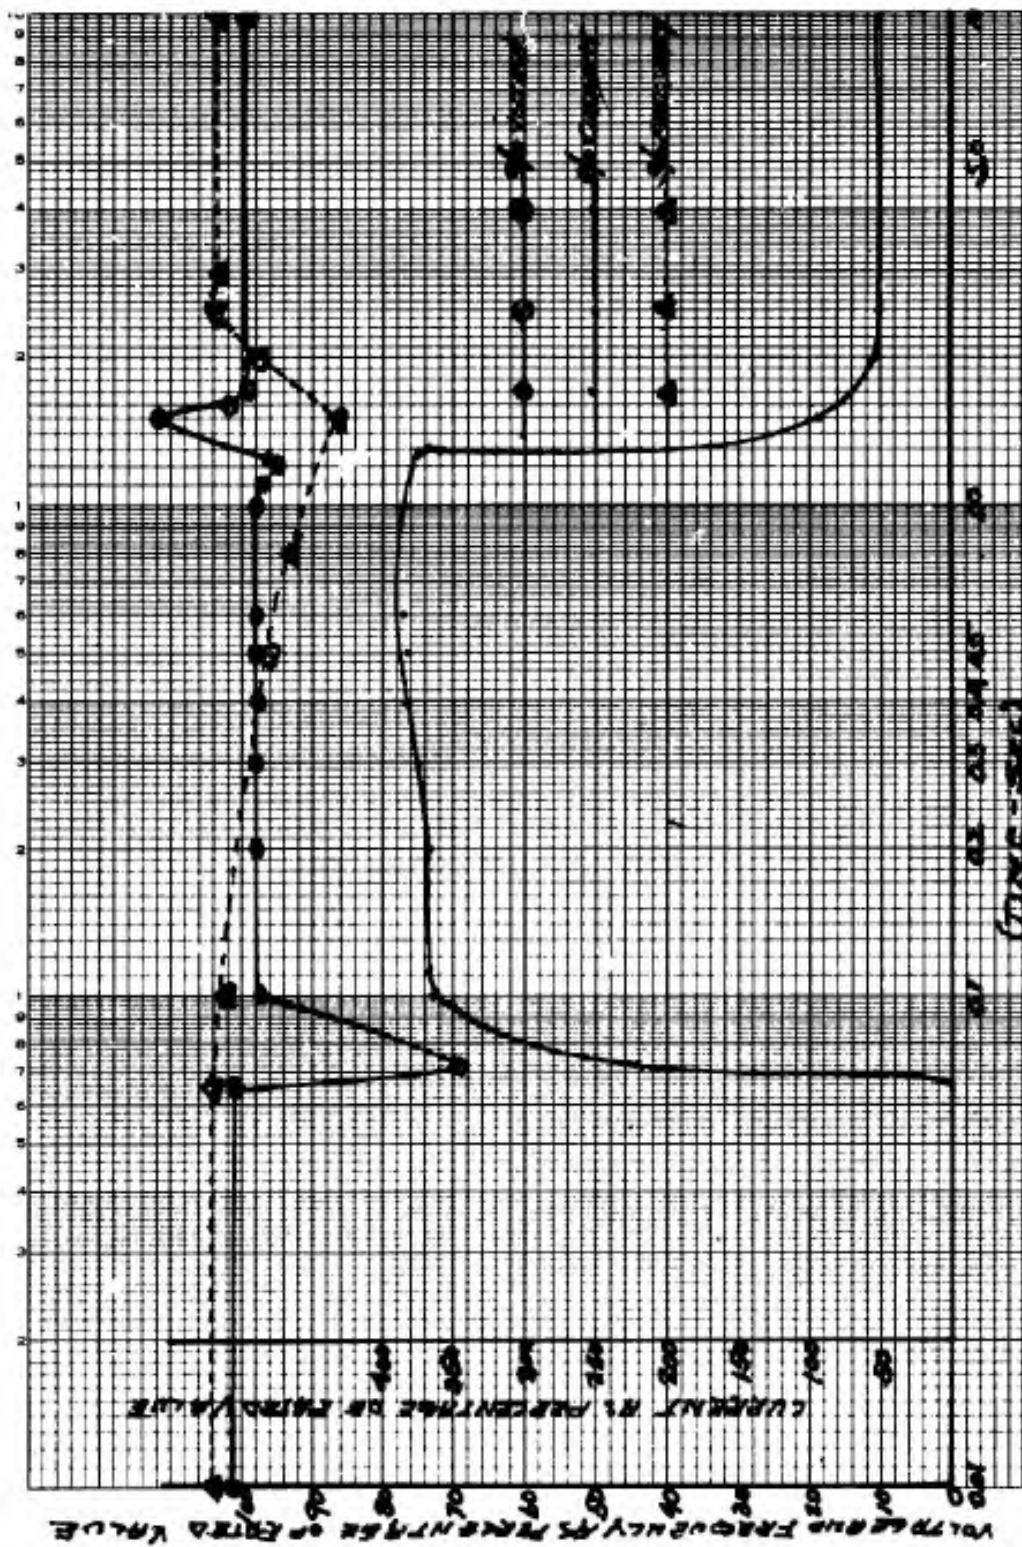
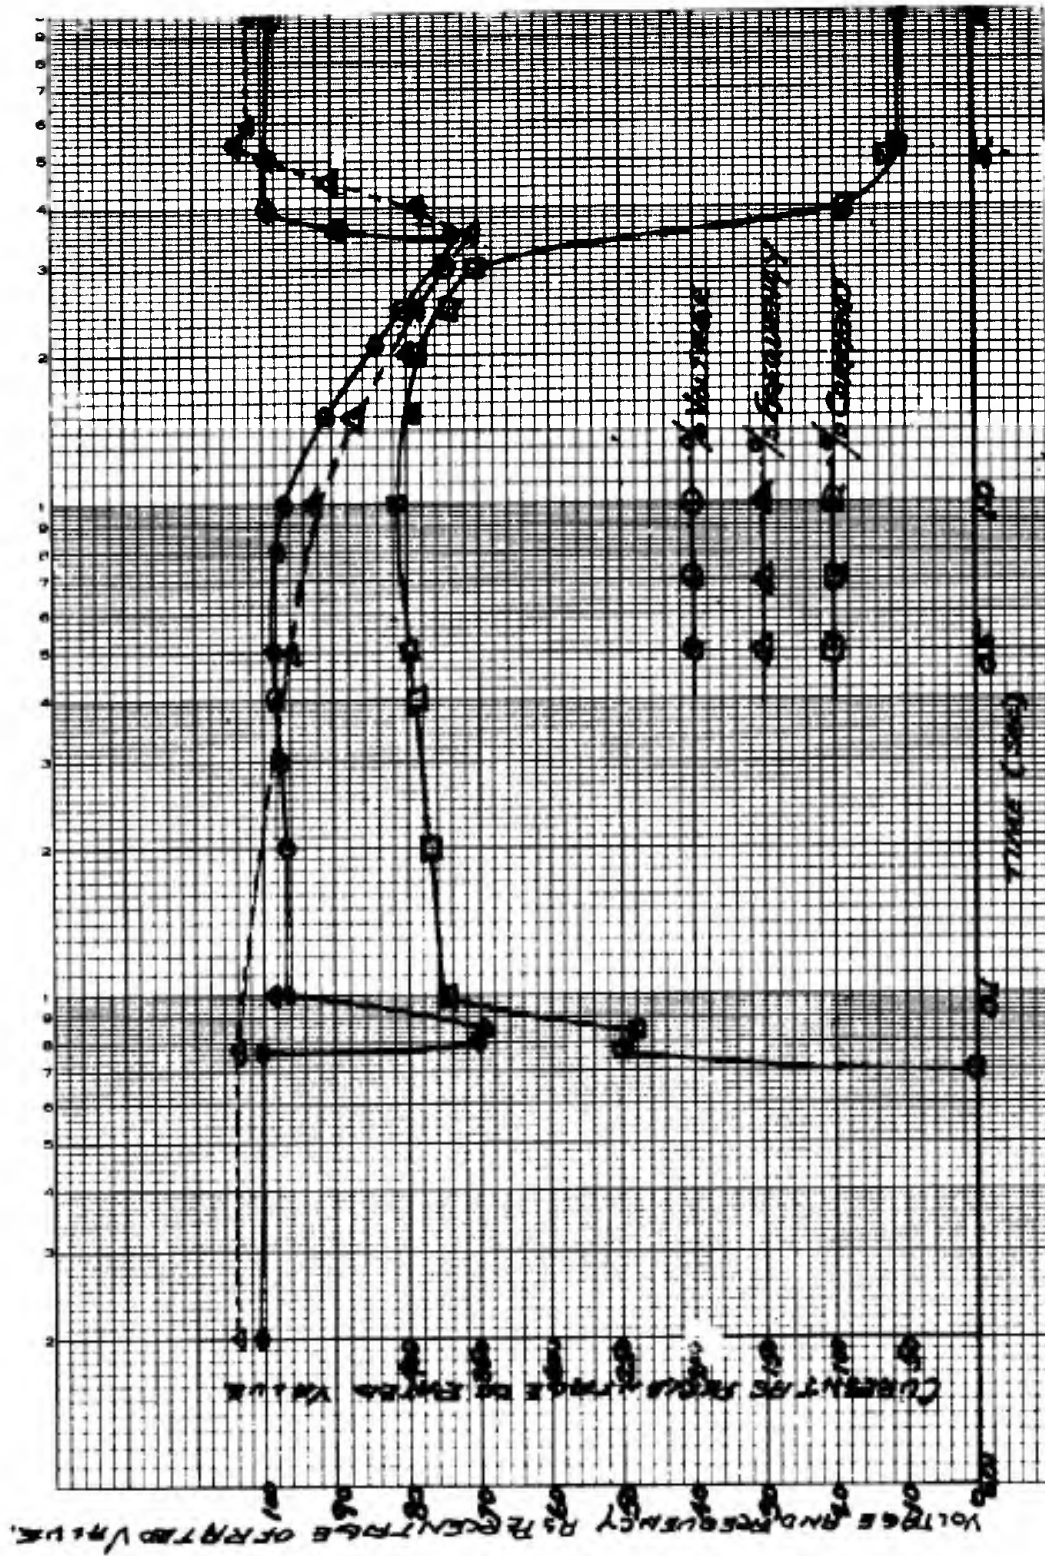
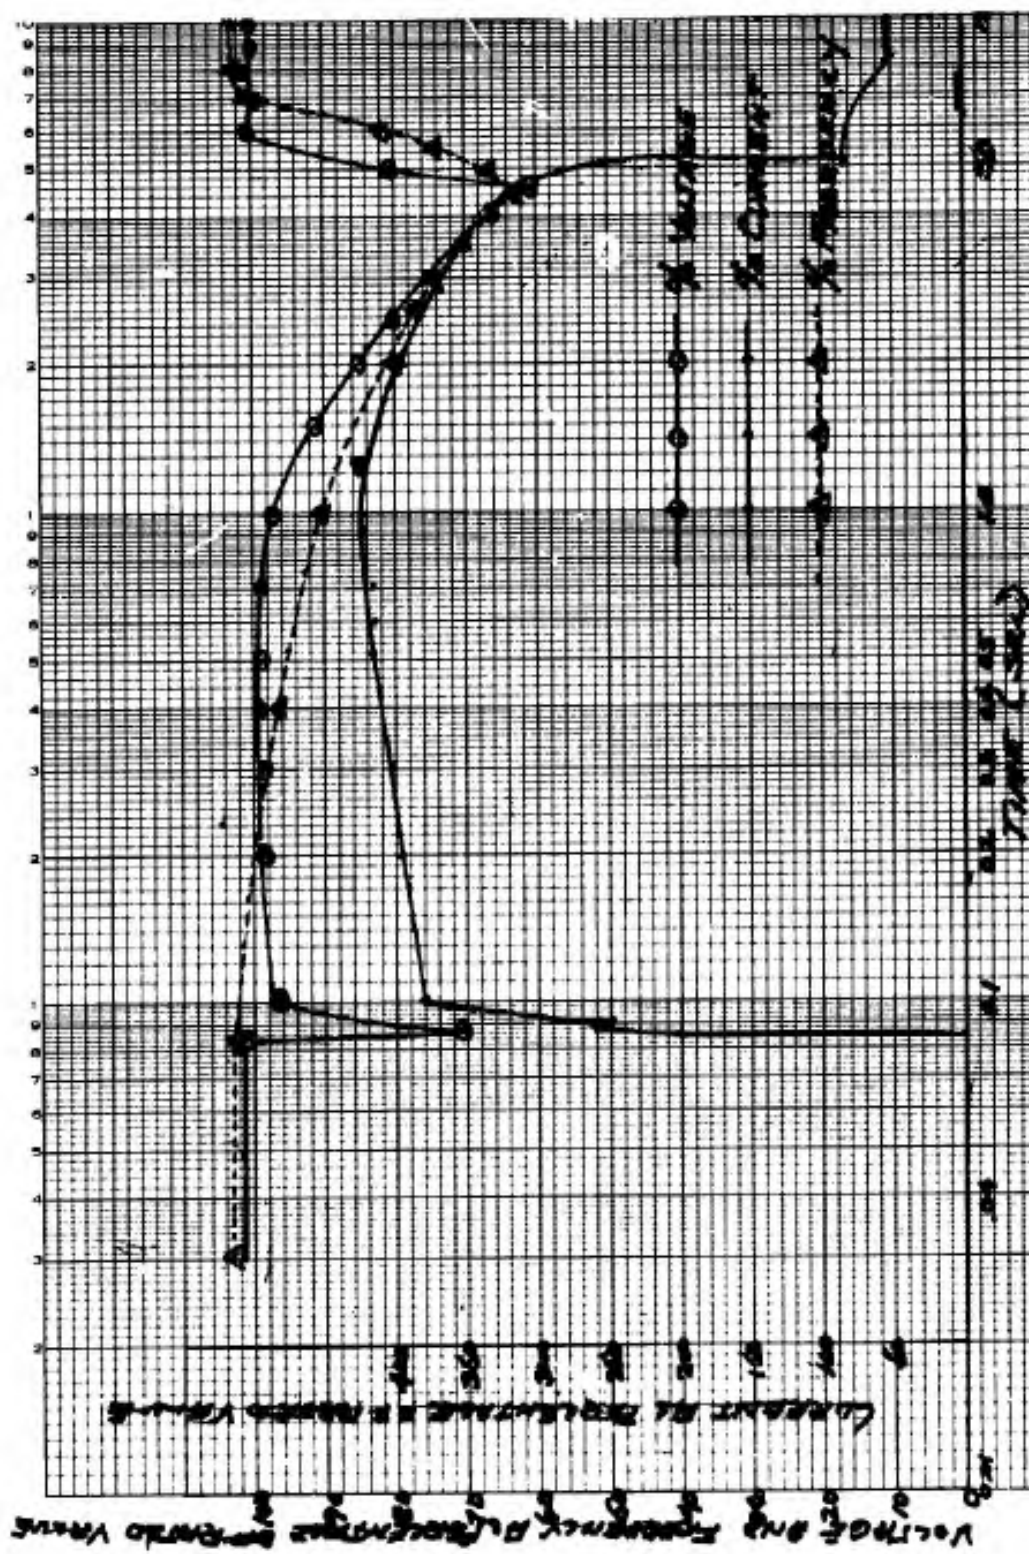
Figures 6, 7, and 8 present the results of this test. As seen in each figure, the voltage initially dropped to approximately 70 percent of rated voltage. As more inertia load was added to the motor, the frequency transient increased. The engine generator set was able to recover under all conditions without having any protective devices actuate. Also, the recovery time increased with an increase in motor load as shown in the figures. Since no requirement was specified in the Purchase Description, this test was conducted for information only.

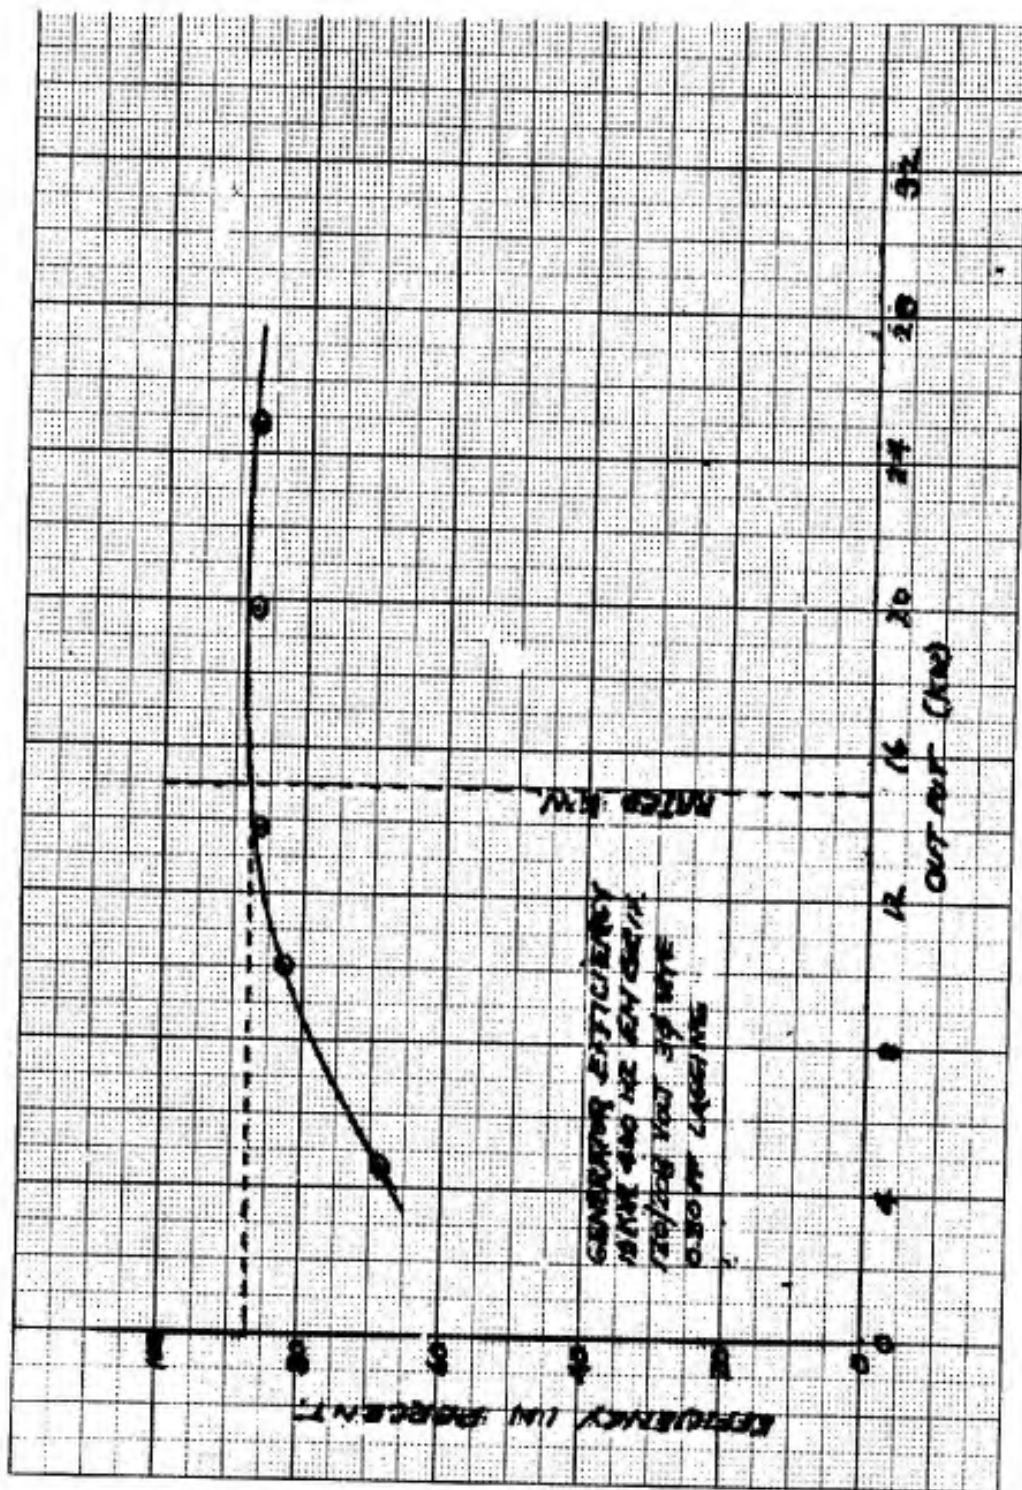
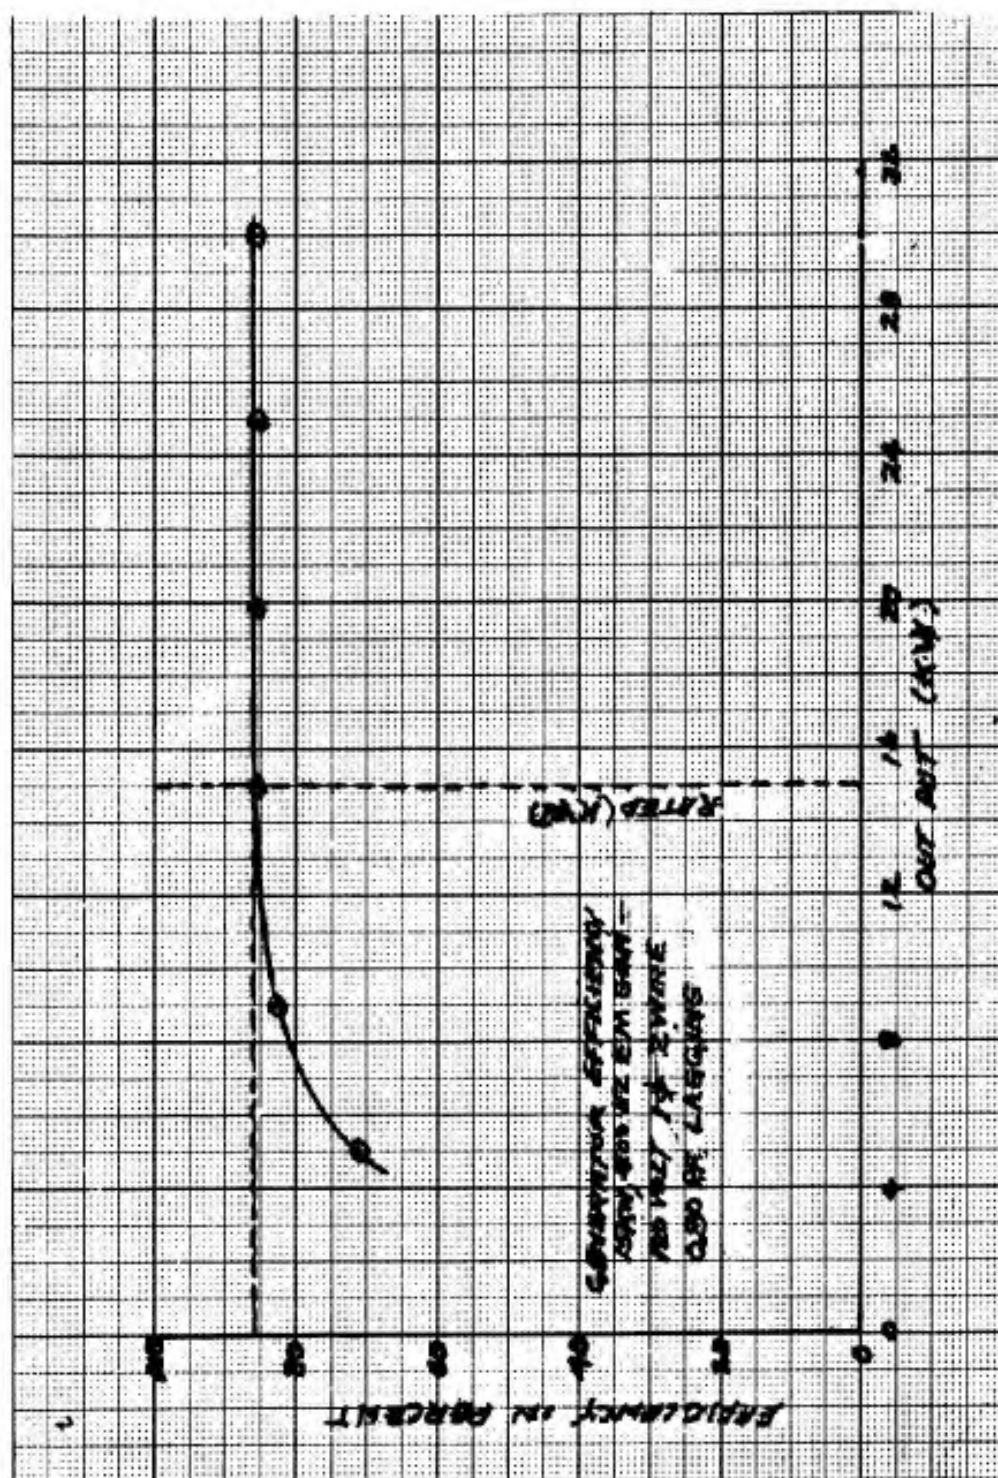
(1) Efficiency. The efficiency of the generator was determined at both the single-phase and 3-phase connections. The results of this test are shown in Figs. 9 and 10. During this test, separate excitations were used for the alternator field. The alternator was loaded at 0.80-pf and the output determined by wattmeter readings. The input was the sum of power measurements made for the rotating field (voltage and current) and the dynamometer indication (pounds pull and speed).

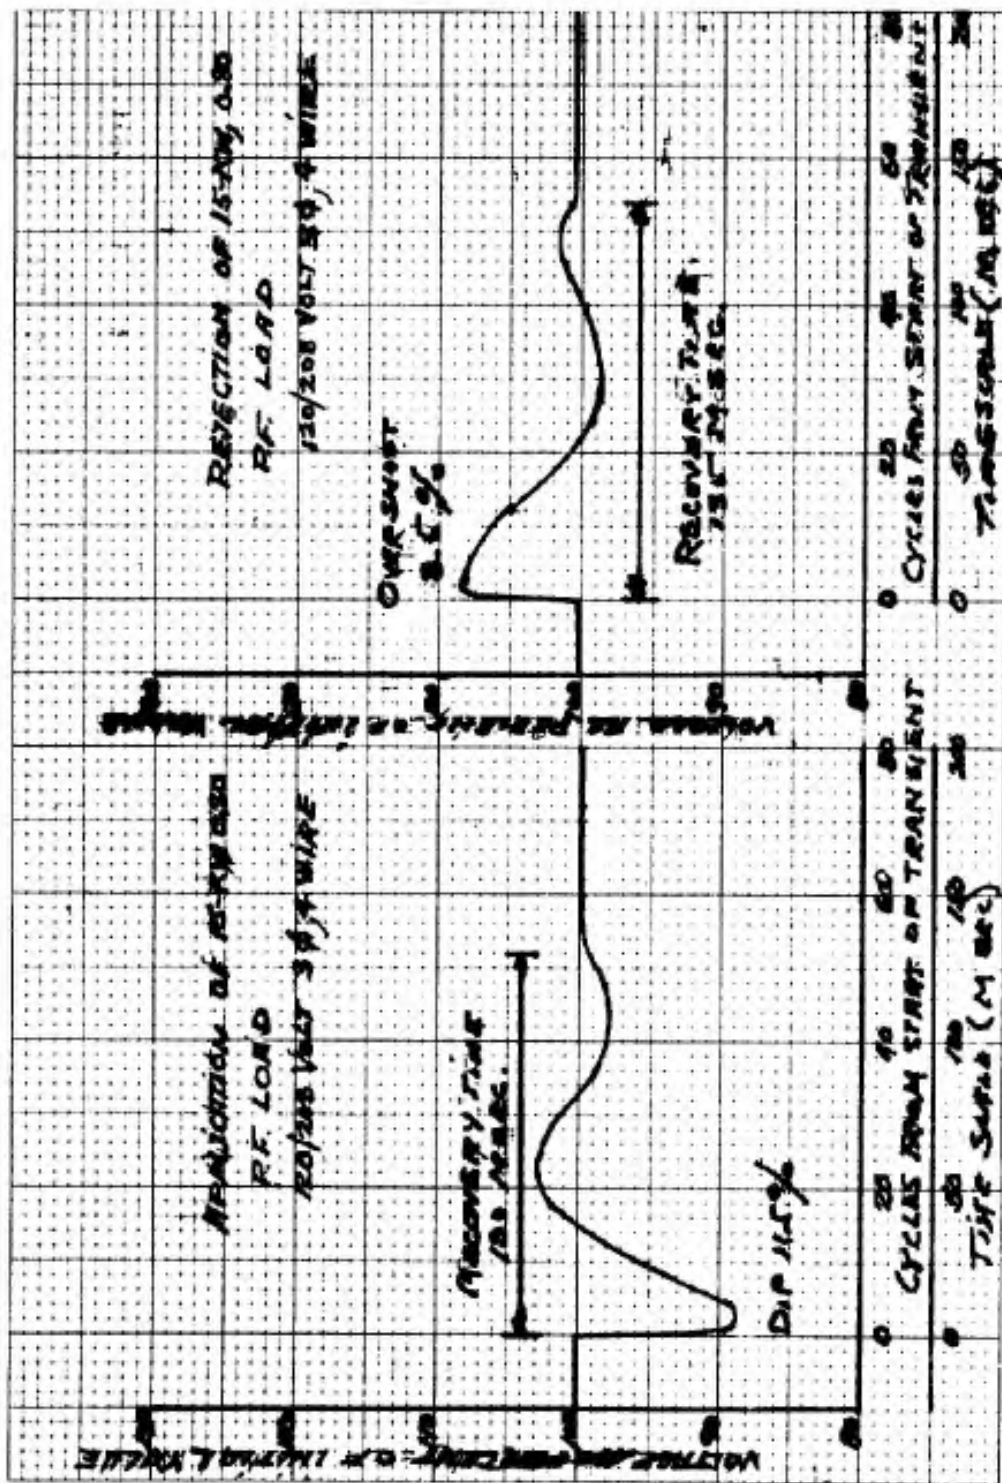
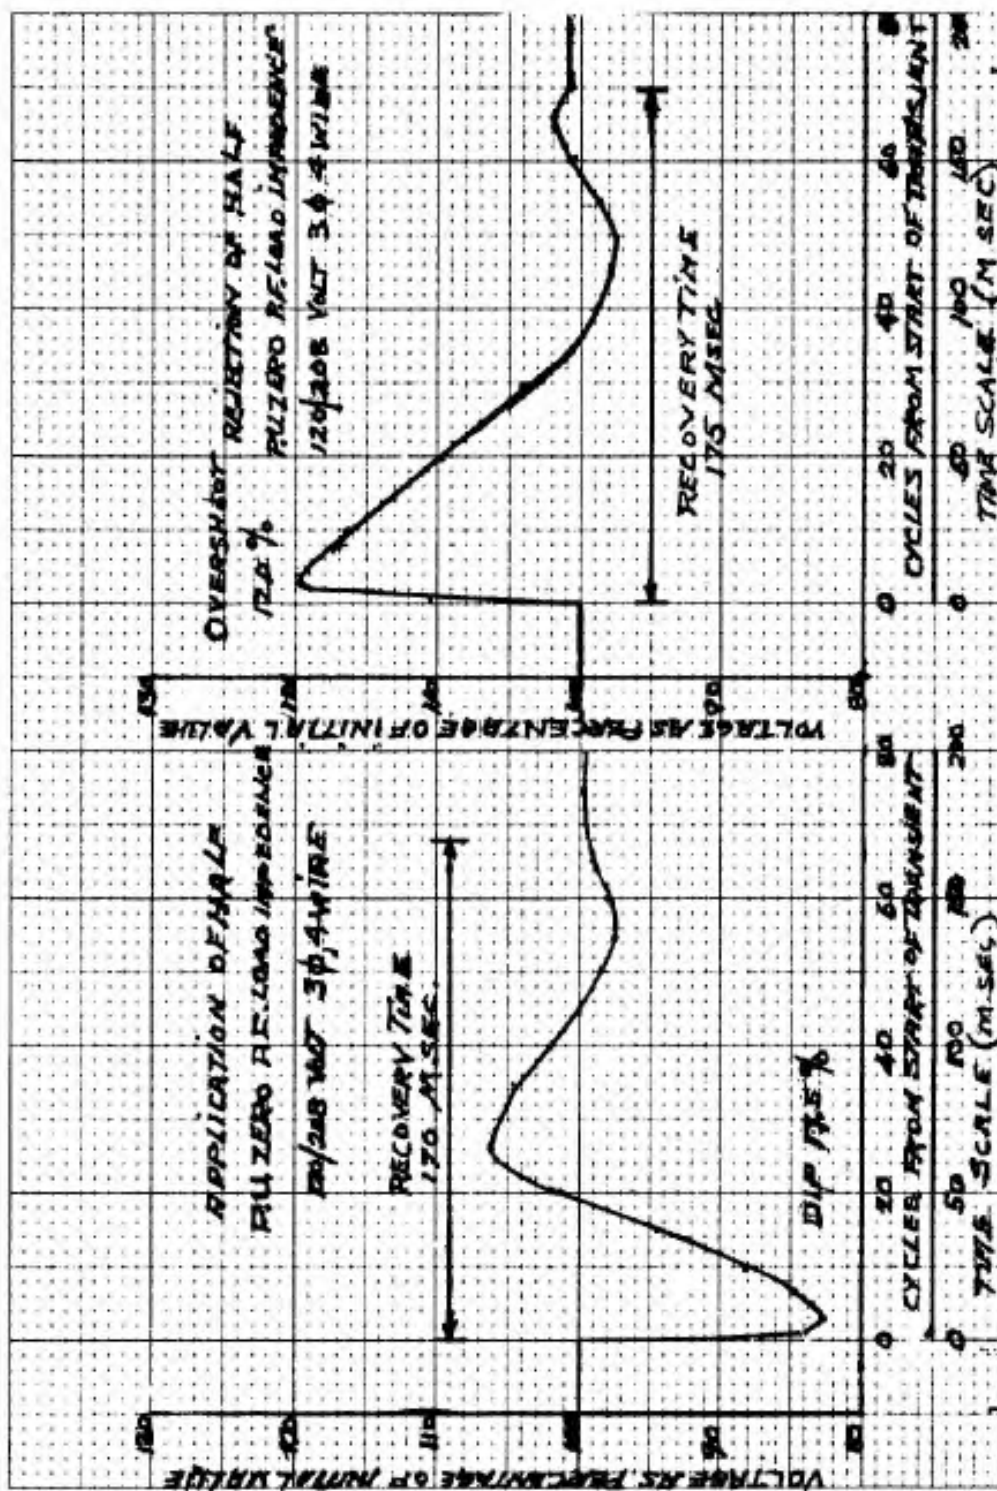
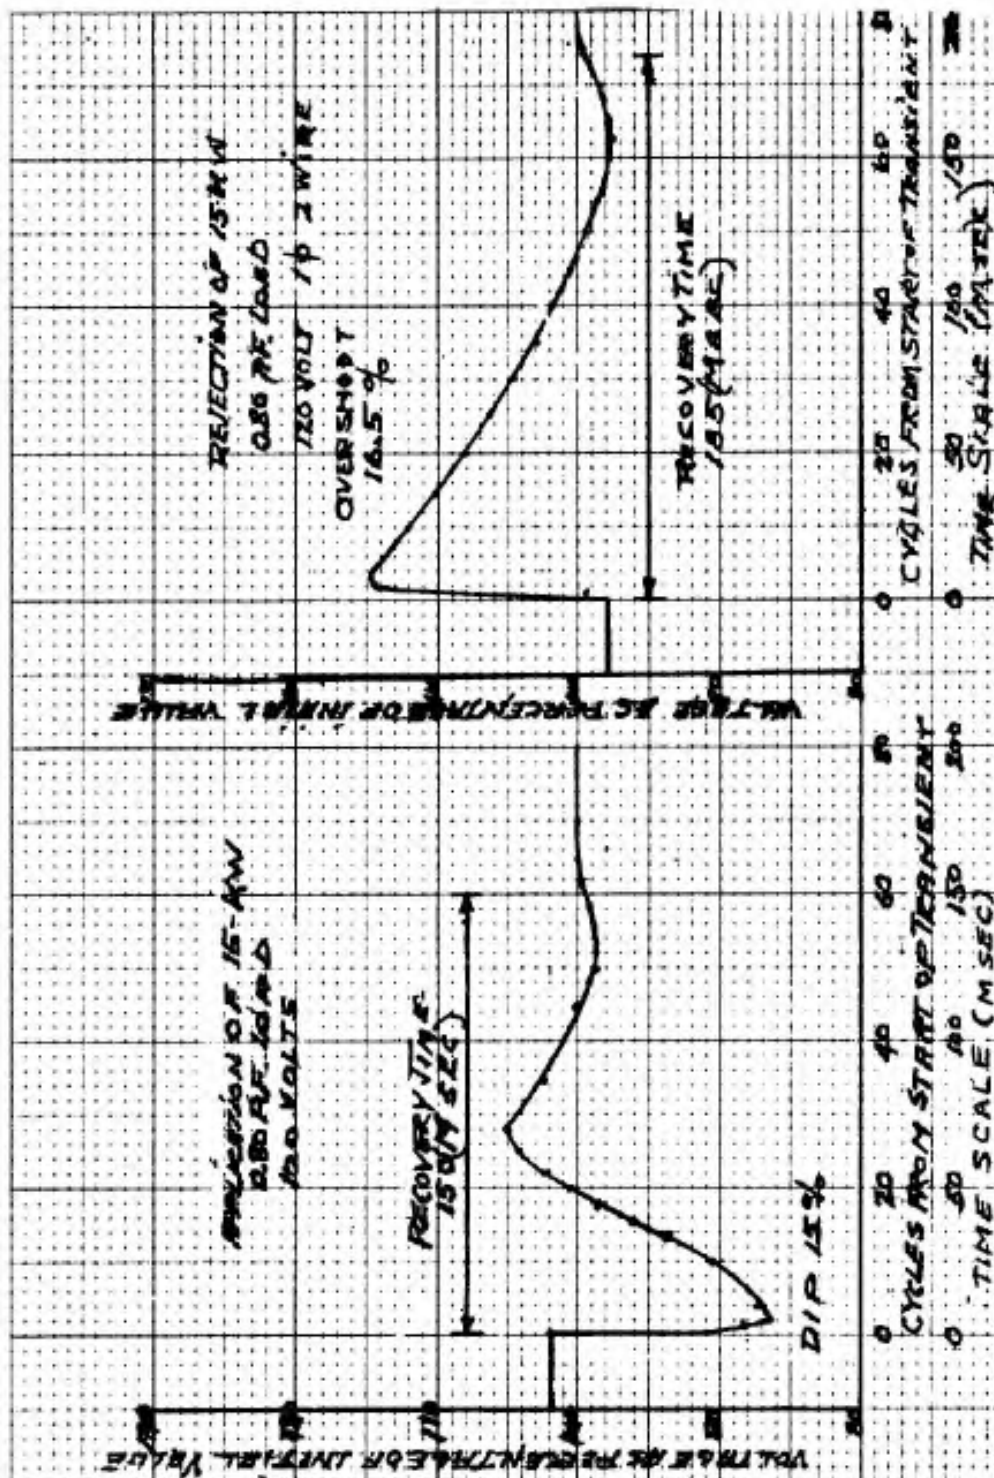
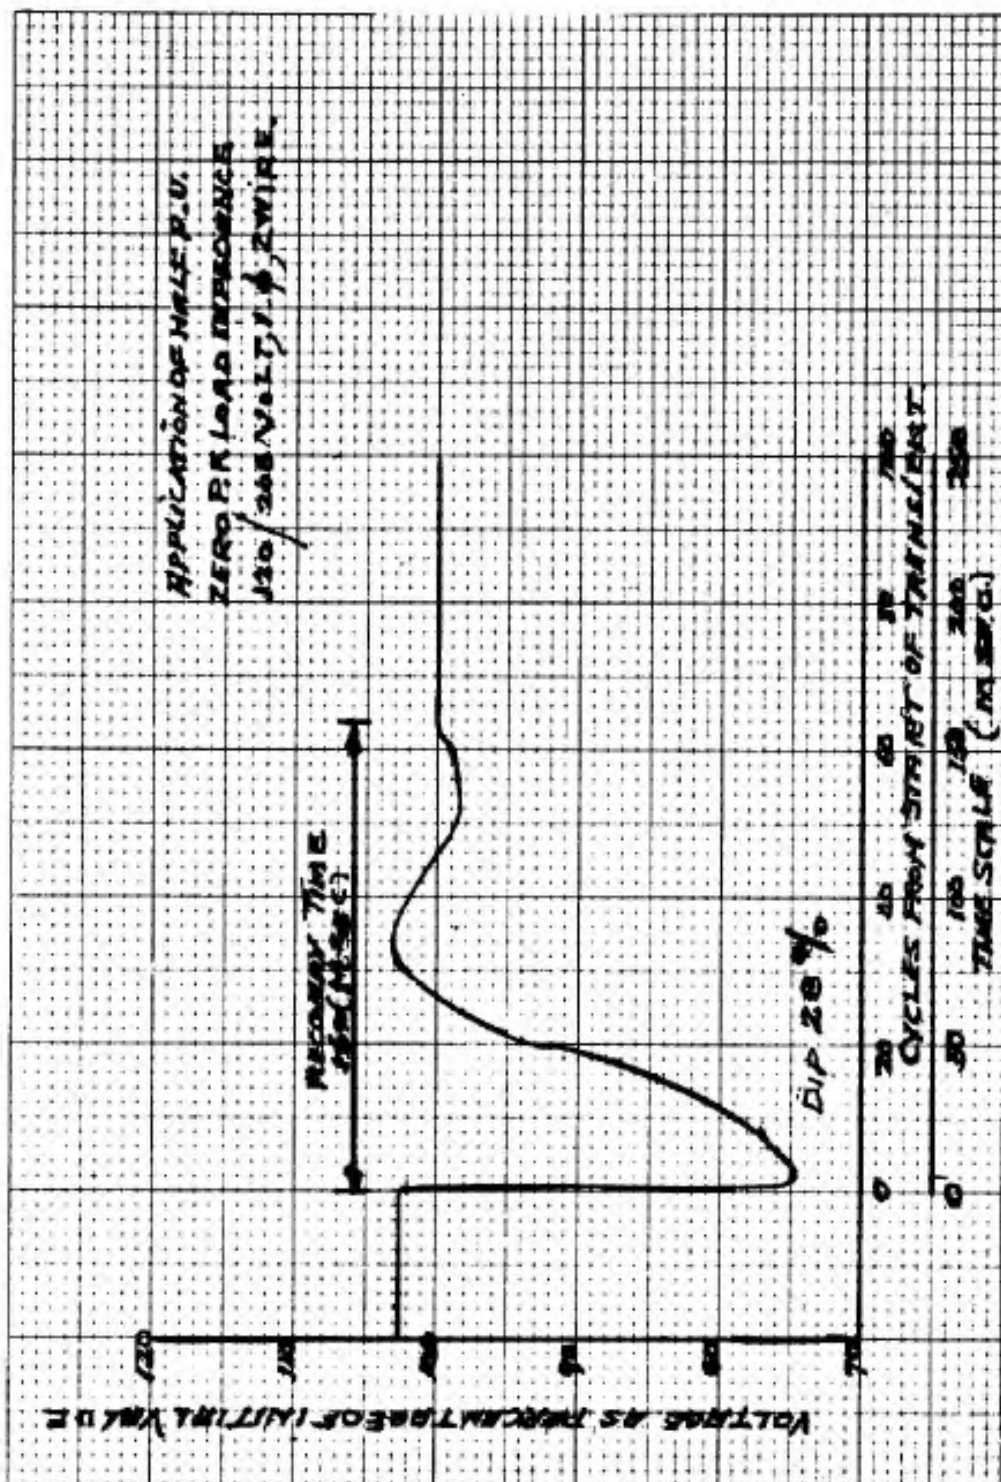
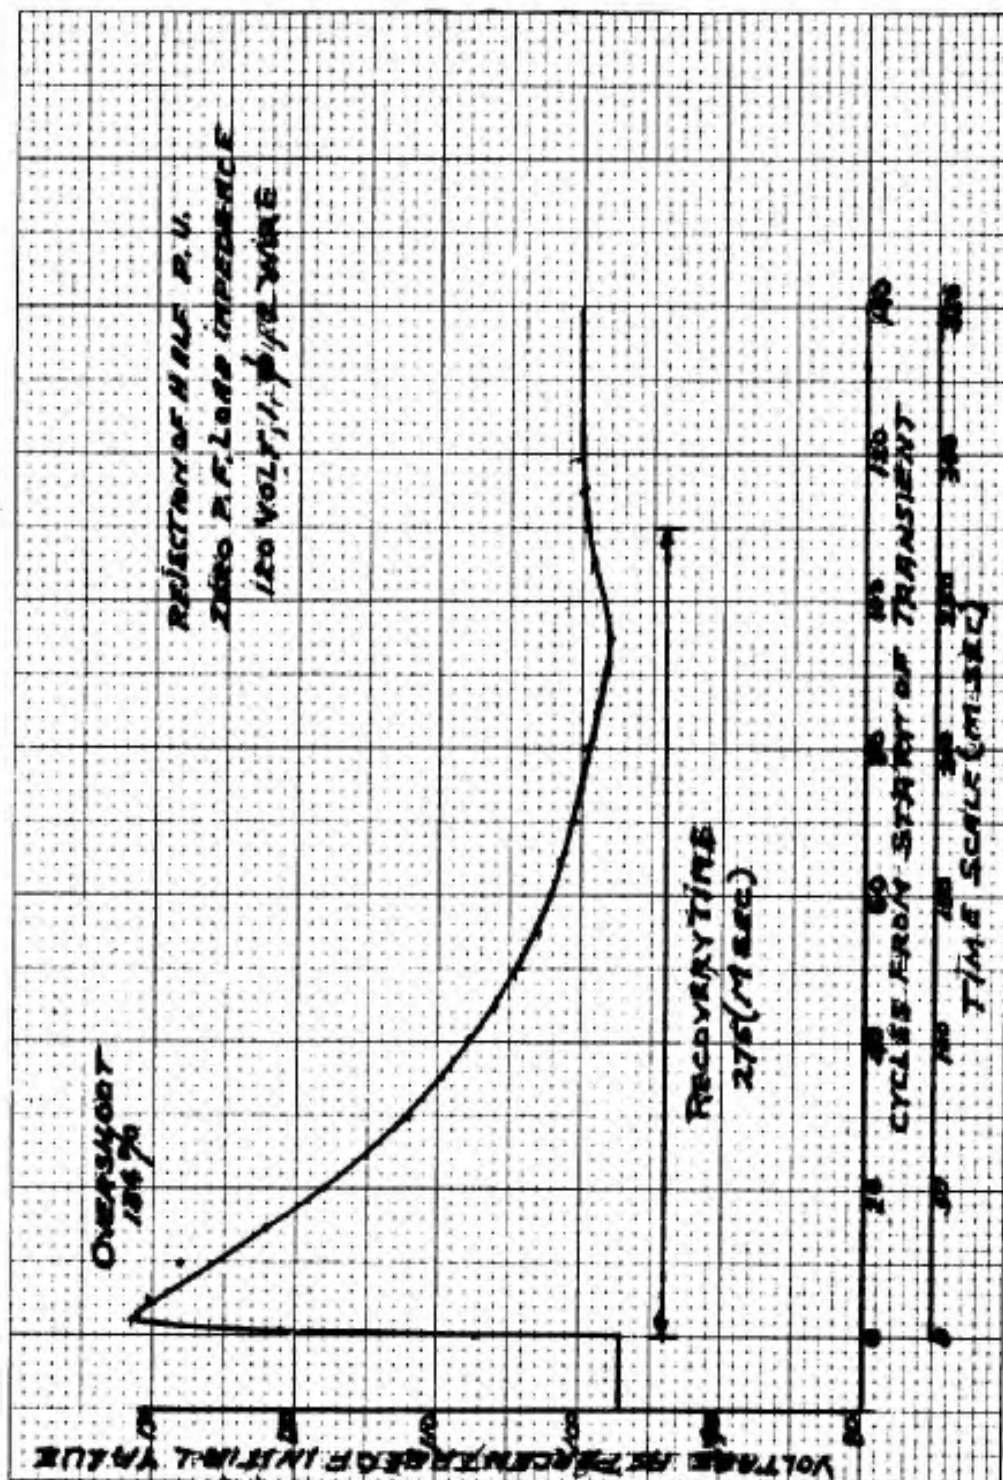
(2) Regulator Stability and Transient Response. Results of these tests, on equipment as received at MERDC, are shown in Figs. 11 through 15. After this data was taken, it was learned (at MERDC and also at the contractor's plant) that the voltage-regulator control was excessive on most units being produced; this would not permit adjusting voltage to the specified minimum value. The generator excitation system was designed to operate with a nominal control current of 1.0 ampere. The first production sets had control current as high as 1.80 amperes. This value approaches the output limit of the voltage regulator and does not allow for proper operation. Investigation revealed that an interference occurred during manufacture of the exciter Current-Voltage Transformer (CVT) which introduced an air gap in the laminations. This gap necessitated a higher control current. A correction in manufacturing was made to eliminate the air gap in the CVT's; and regulator stability and transient response tests were repeated at MERDC using an exciter equipped with the new CVT's. Control current was 0.75 ampere for rated generator output voltage, and performance was improved in that the lower limit of the specified range of voltage adjustment could now be obtained; however, the stability after shock loading was relatively poor as denoted by the relatively large number of voltage oscillations which took place after the load was changed. Figures 16 and 17 illustrate this condition. By adjusting the stability resistor (R-11) in the voltage regulator, it was possible to improve stability to an acceptable value. Figures 18 and 19 show results obtained after this adjustment and are the basis of the data included in Table III. As a further check on the effectiveness of the change, two additional sets of the new CVT's were installed in the exciter in turn. Performance was satisfactory and not significantly different.
